DEPARTMENT OF TRANSPORTATION

Quality Assurance and Source Inspection

Contract #: 04-0120F4Cty: SF/ALA Rte: 80 PM: 13.2/13.9File #: 69.28**WELDING INSPECTION REPORT****Resident Engineer:** Siegenthaler, Peter**Address:** 333 Burma Road**City:** Oakland, CA 94607**Report No:** WIR-017997**Date Inspected:** 05-Nov-2010**Project Name:** SAS Superstructure**OSM Arrival Time:** 700**Prime Contractor:** American Bridge/Fluor Enterprises, a JV**OSM Departure Time:** 1900**Contractor:** Zhenhua Port Machinery Company, Ltd (ZPMC), Changxing Island **Location:** Shanghai, China**CWI Name:** Mr. Tian lei**CWI Present:** Yes No**Inspected CWI report:** Yes No N/A**Rod Oven in Use:** Yes No N/A**Electrode to specification:** Yes No N/A**Weld Procedures Followed:** Yes No N/A**Qualified Welders:** Yes No N/A**Verified Joint Fit-up:** Yes No N/A**Approved Drawings:** Yes No N/A**Approved WPS:** Yes No N/A**Delayed / Cancelled:** Yes No N/A**Bridge No:** 34-0006**Component:** Orthotropic Box Girder(OBG)**Summary of Items Observed:**

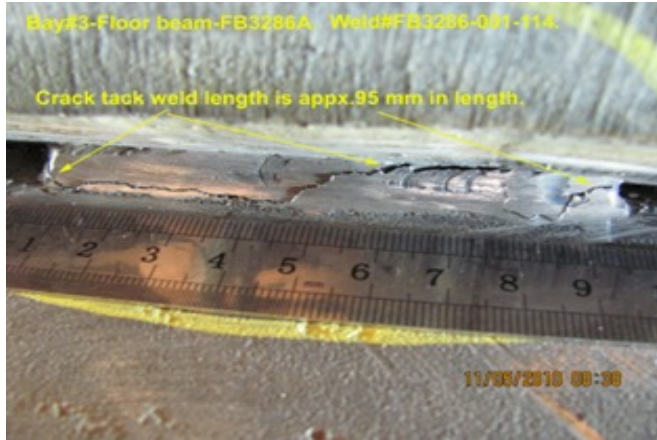
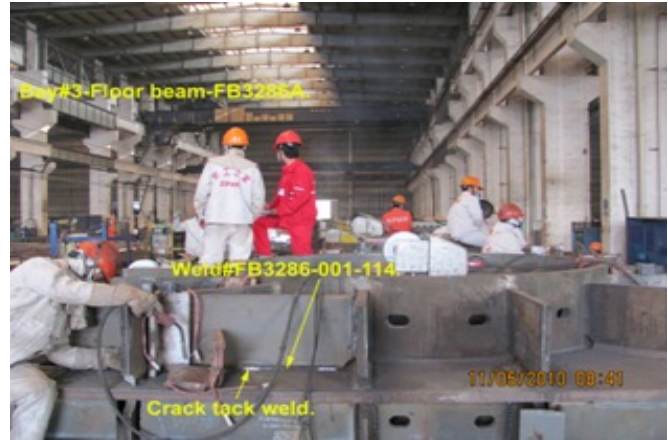
During random in process inspection of OBG member identified as Lift 14 Floor beam FB3286A, this QA observed a cracked tack weld on weld joint identified as FB3286-001-114. This QA marked the cracked tack and informed ZPMC Quality Control (QC) indentified as Mr. Zhan hai feng of this issue. Mr. Zhan hai feng informed this QA that the cracked tack would be corrected in a manner compliant with the contract documents. Refer the attached photos for reference.
